Complaint Inspection Report Rector Frocteau Property 25820 Comptche-Ukiah Rd. Comptche

Date: April 22, 2010

Subject: February 9, 2010 inspection of Rector/Frocteau Property

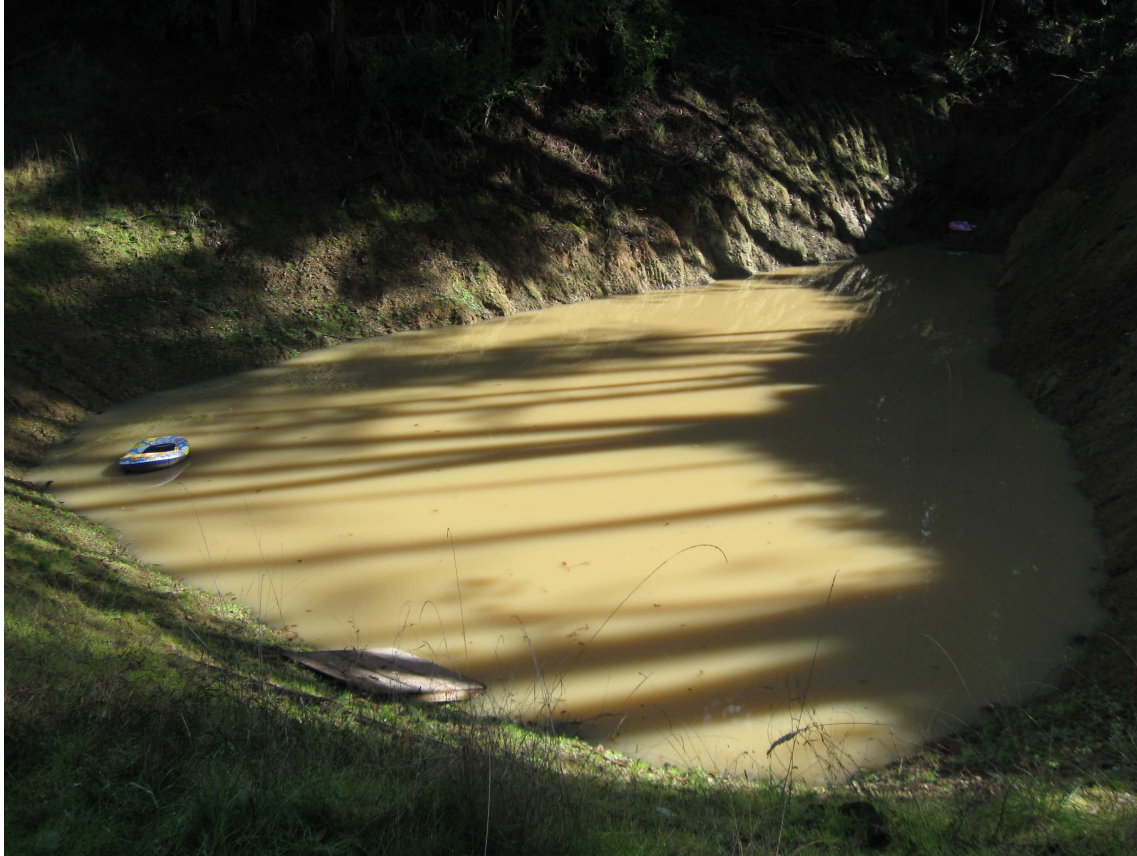
1/14/2010 Rector/Frocteau Property in-stream impoundment approximately 12 feet to water from top of impoundment

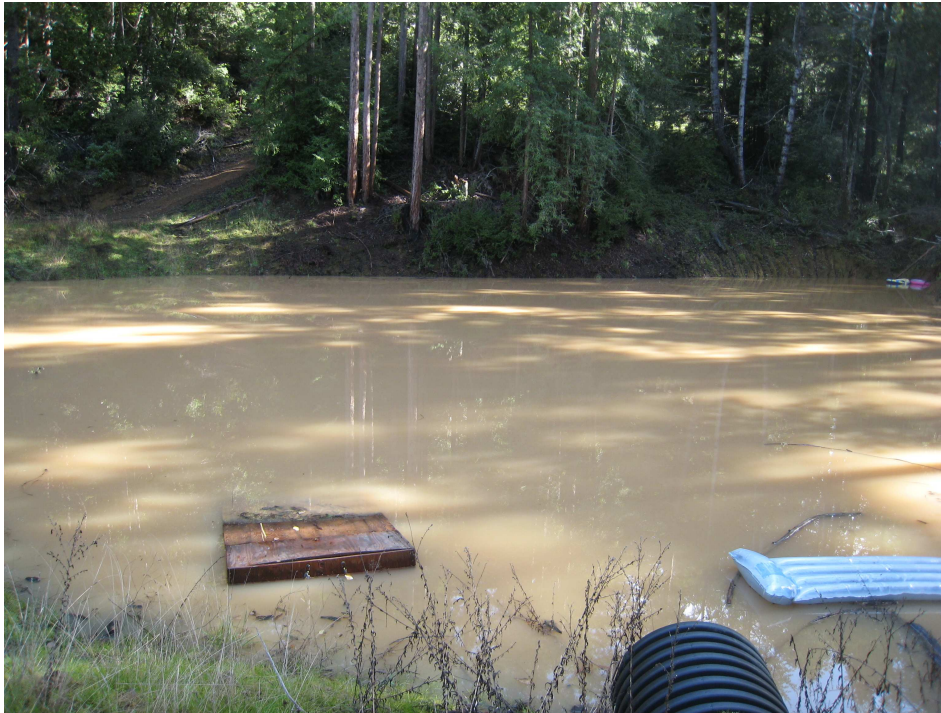
2/9/2010 The Rector/Frocteau Property in-stream impoundment at full capacity, (note the floating debris a potential spillway plugging hazard). The pond is an estimated minimum depth of 25 feet.

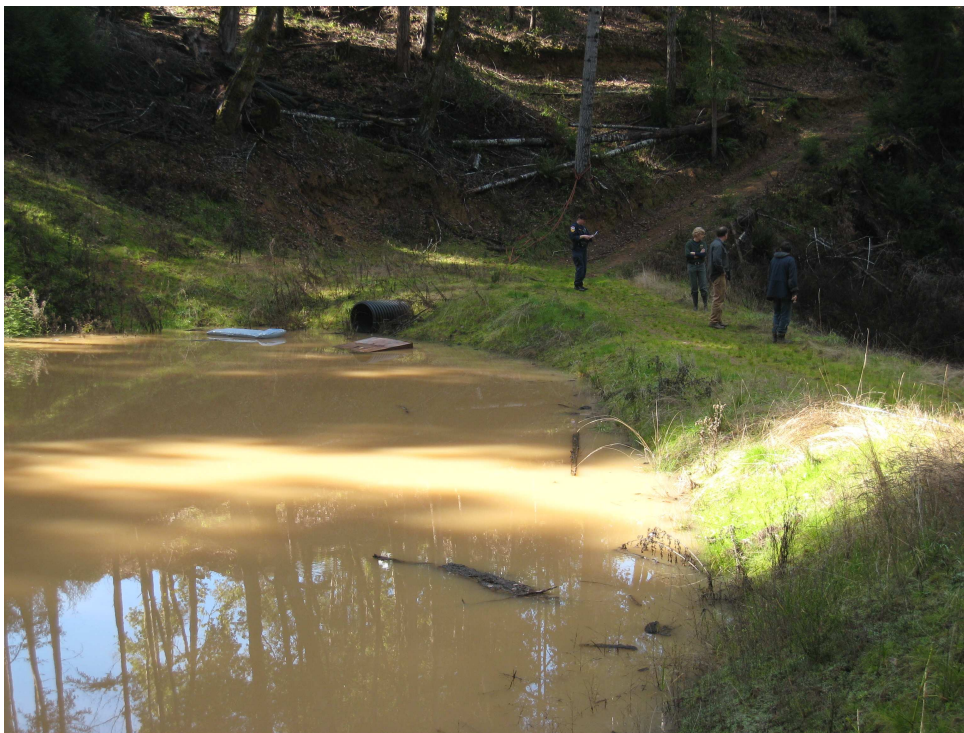
2/9/2010 view of water height and spill way.

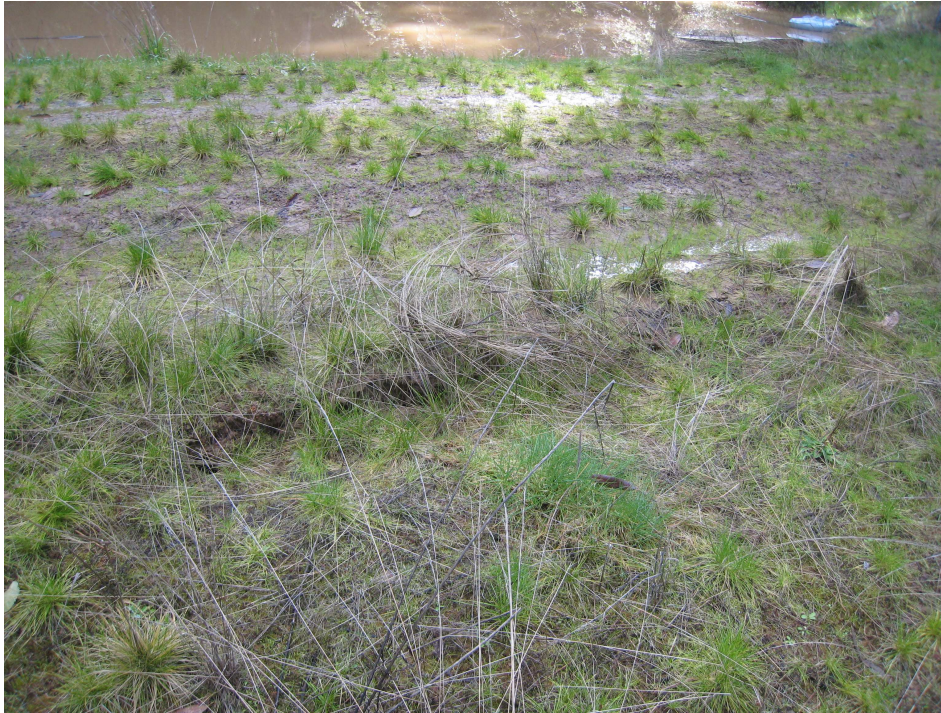
According to the landowner, the impoundment was constructed about a year and a half ago using earthen fill materials. The downstream side of the impoundment surface evidenced tension cracks, which may be a result of poor compaction during construction. These tension cracks appear to have enlarged in the interim three weeks between inspections (1/14/2010-3/9/2010). In addition, the impoundment was at full volume on February 9, 2010 increasing concerns with the potential for a catastrophic failure. The spillway is set very high in the fill of the impoundment and there appears to be some potential for plugging from floating debris. The spillway was observed to be discharging a steady stream of water estimated at 10 to 20 gallons per minute. This spill way flow is along the hinge-line (joining of natural soils and fill materials) of the crossing and disperses as subsurface flow prior to reaching the base of the impoundment fill slope.

2/9/2010 tension cracks and pond in the background to illustrate extent of tension cracks in impoundment fills.

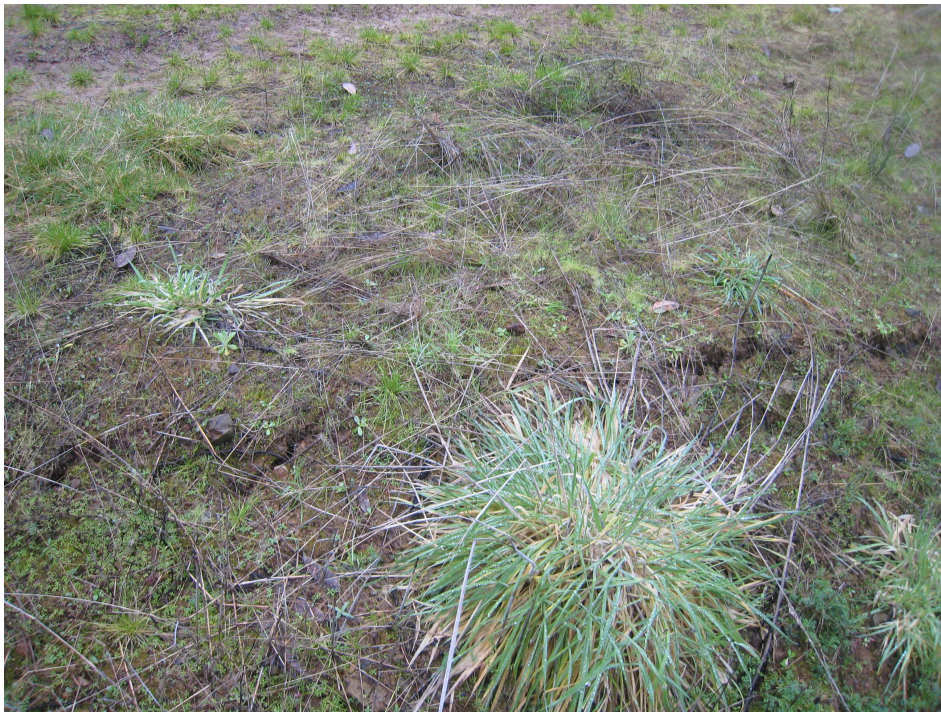
2/9/2010 tension cracks

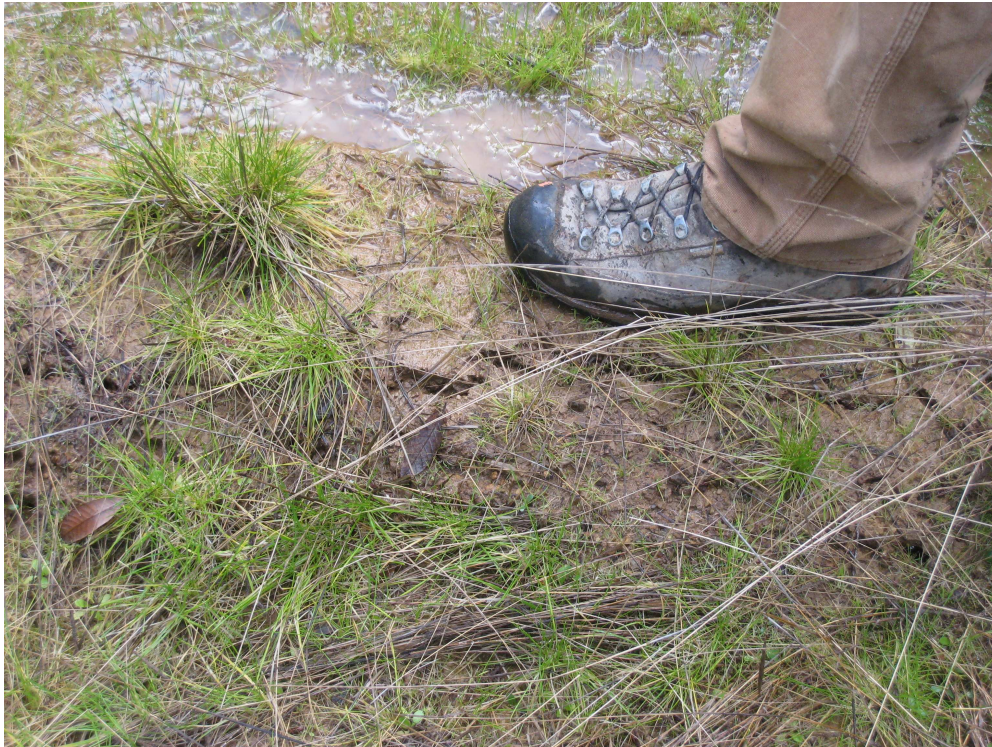
2/9/2010 new tension cracks with 2-3 inches of displacement not observed on 1/14/2010

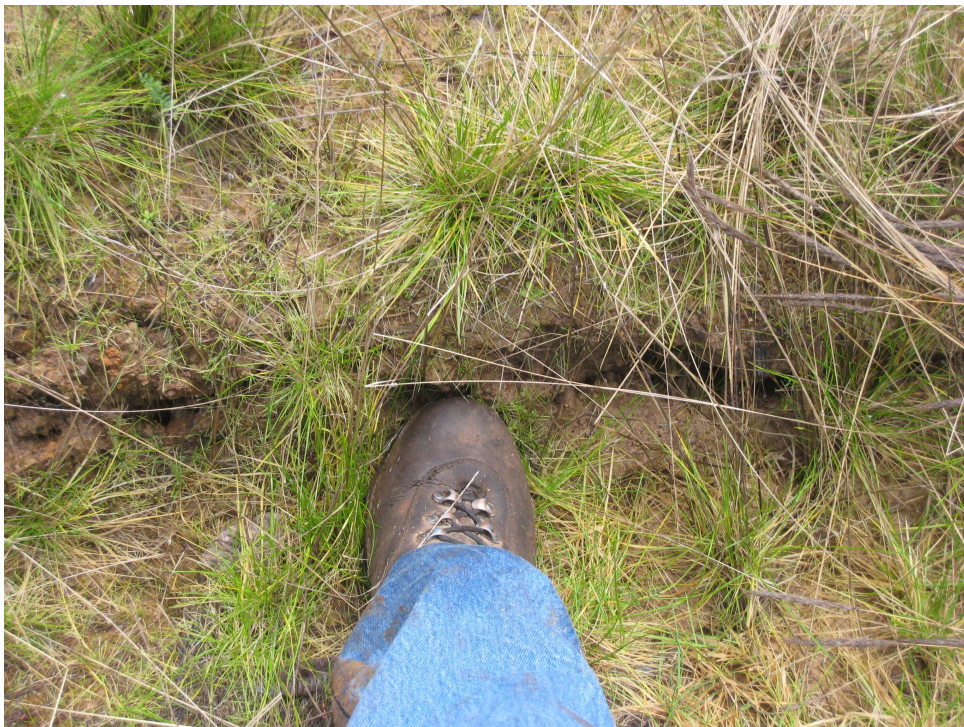
2/9/2010 tension cracks note the offset (2-3 inches) and size of crack in relationship to a size 11 boot.

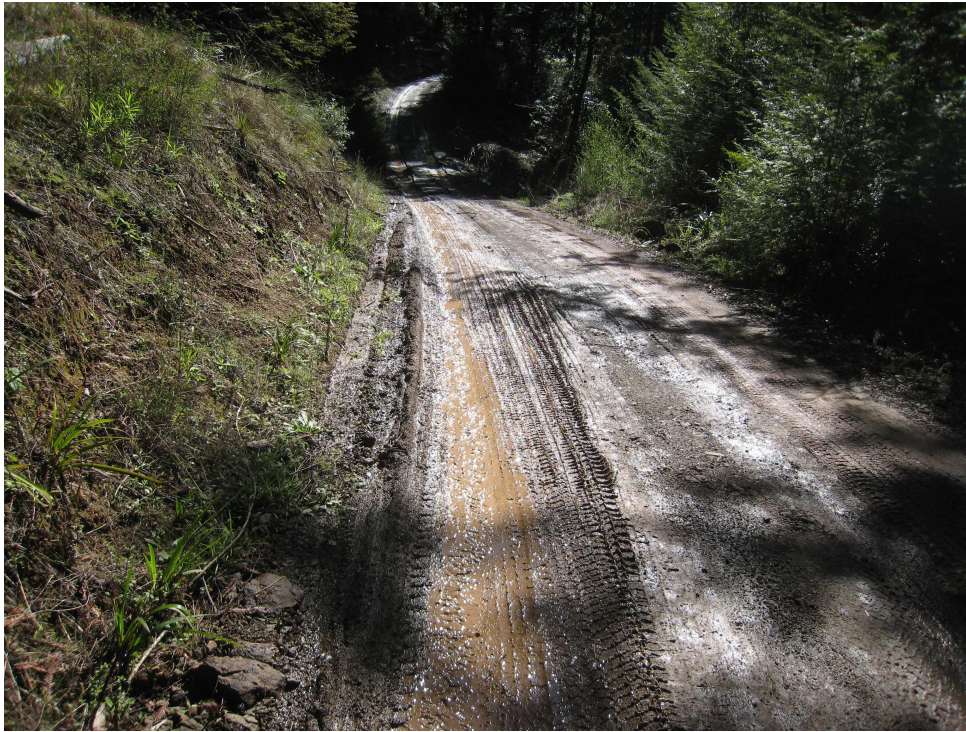
During the February 9, 2010 inspection, discharge of sediment and turbid water was observed from road surfaces at watercourse and swale crossings, and the road surface had significantly deteriorated in the intervening three weeks. The current status of the road surface will require grading, road drainage work to address the discharge and potential for discharge of sediment to waters of the state.

2/9/2010 road surface ruts channelize flow to watercourse/swale drainage point below.

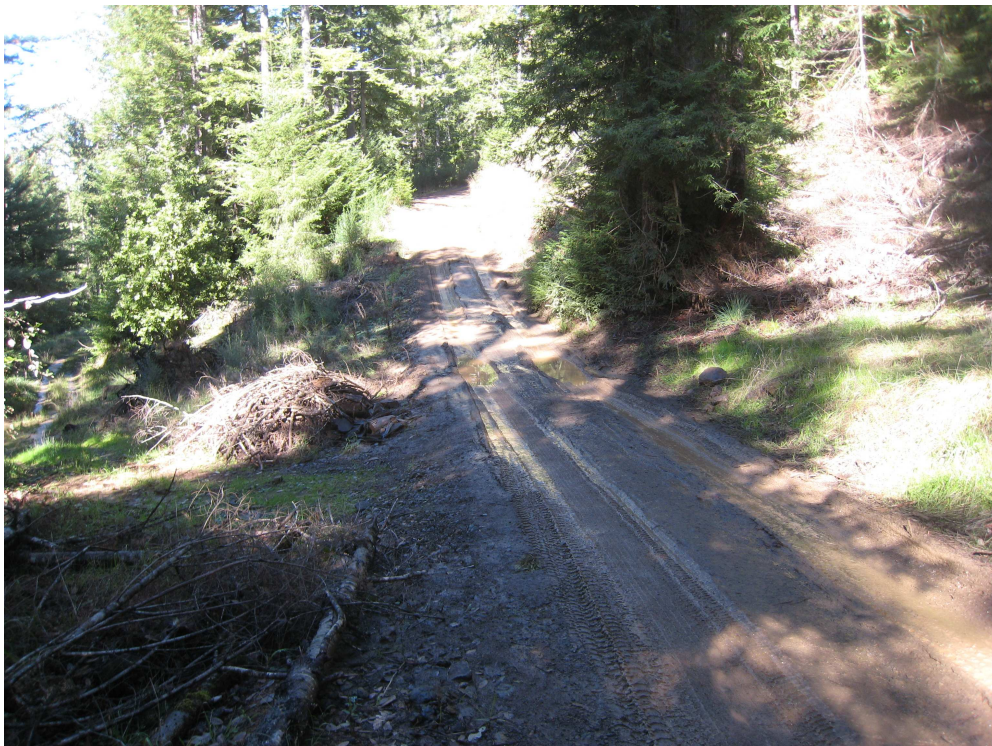
2/9/2010 road surface erosion delivers at unmaintained watercourse crossing below.

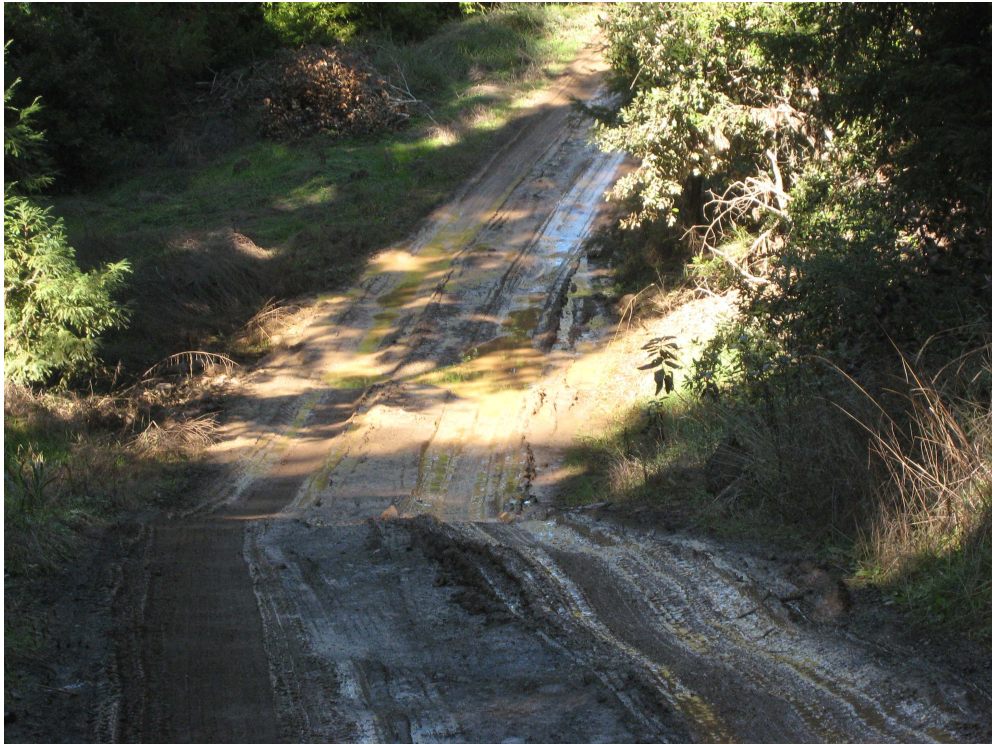
2/9/2010 closer view of watercourse crossing in previous photo

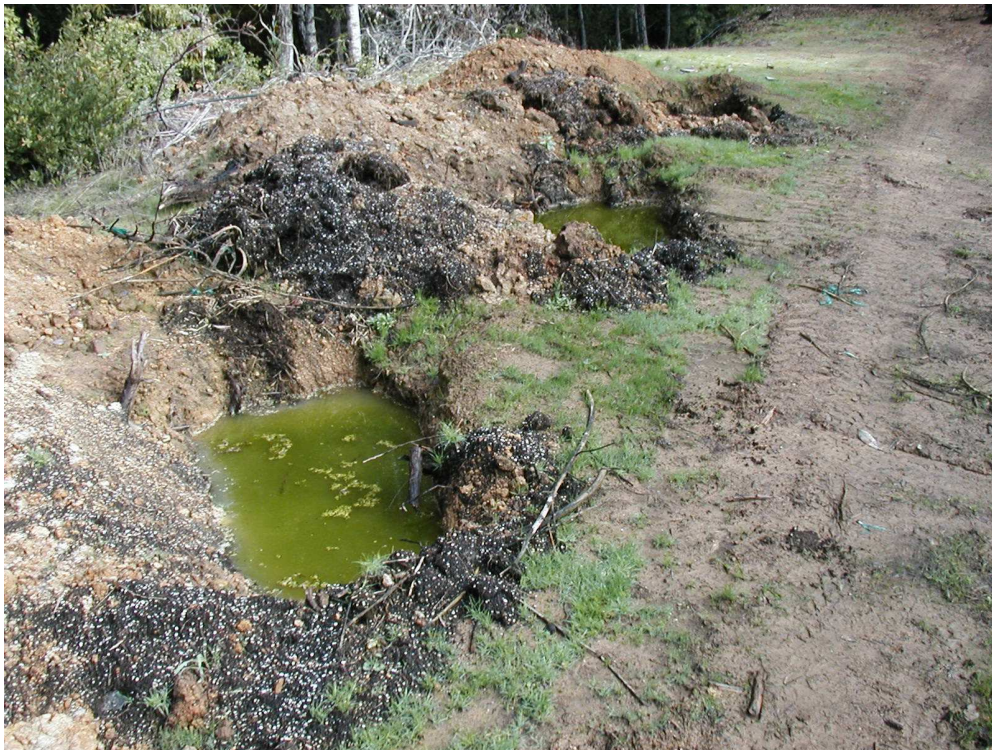
1/14/2010 agriculture cultivation holes adjacent to Rector-Frocteau home site
